SUREFIRE RESIDENTIAL REPORT

1234 Main Street
Melrose Park, IL 60160

Buyer Name
01/16/2024 9:00AM

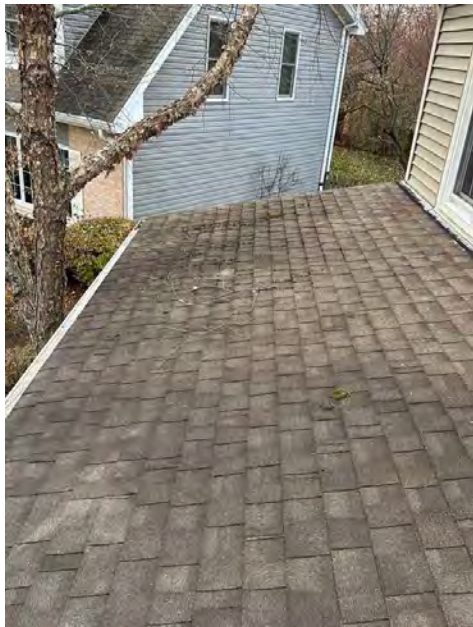
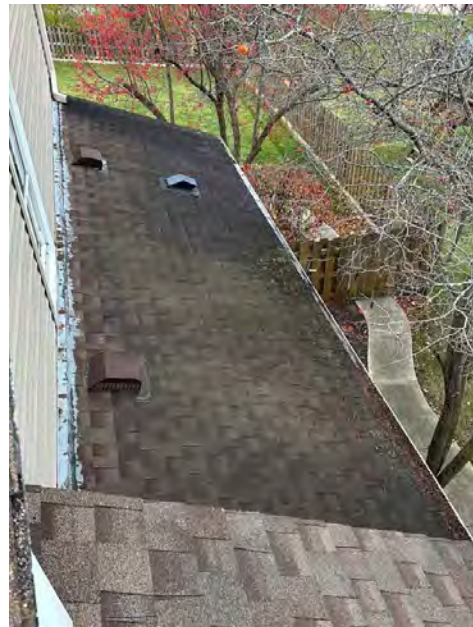
Algae growth can deteriorate and shorten the life of the roofing material. It is highly suggested that the roof be clean and treated as soon as practical.

Repair

Contact a qualified roofing professional.

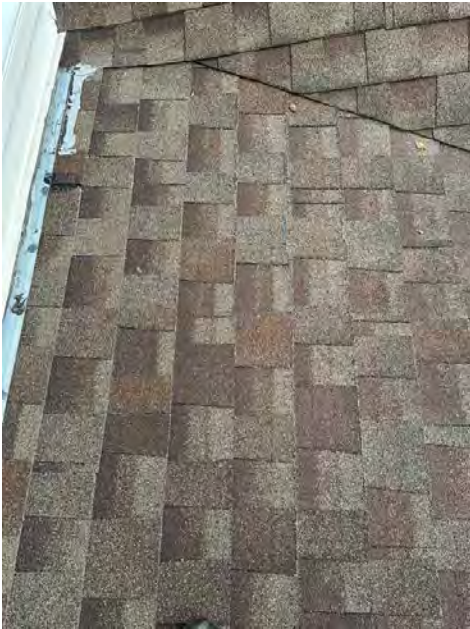
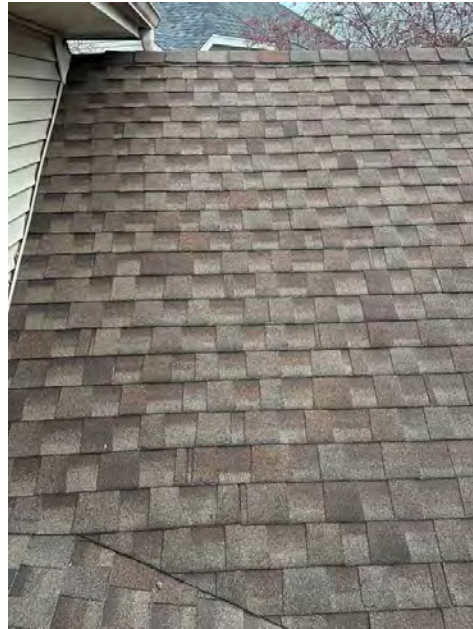
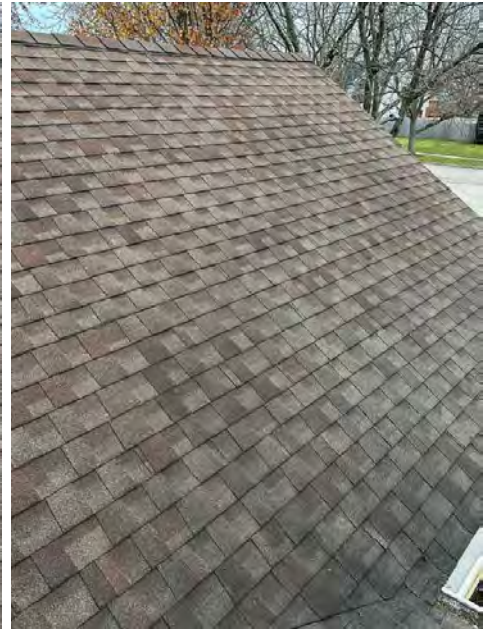
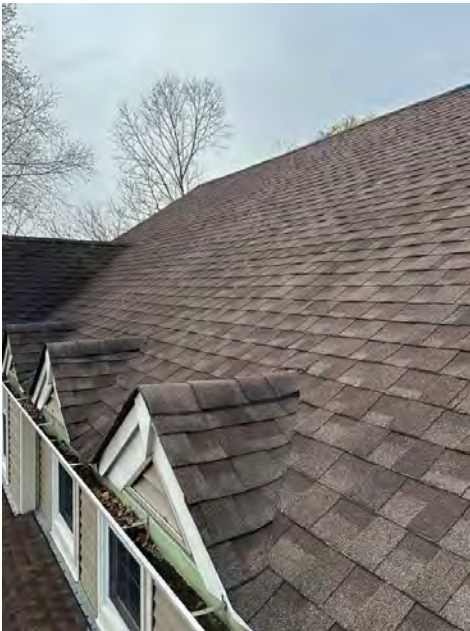
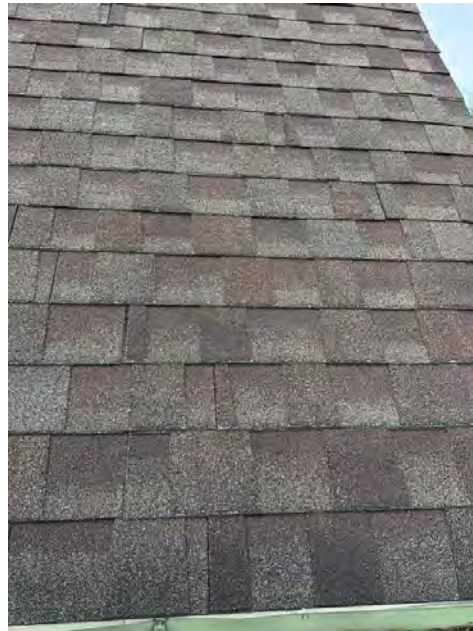
2.2.2 Sloped Roof Material

GRANULE DETERIORATION

Accumulation of granules is generally an indication that your roof needs attention. This can cause potential drainage conditions.

Repair

Contact a qualified roofing professional.

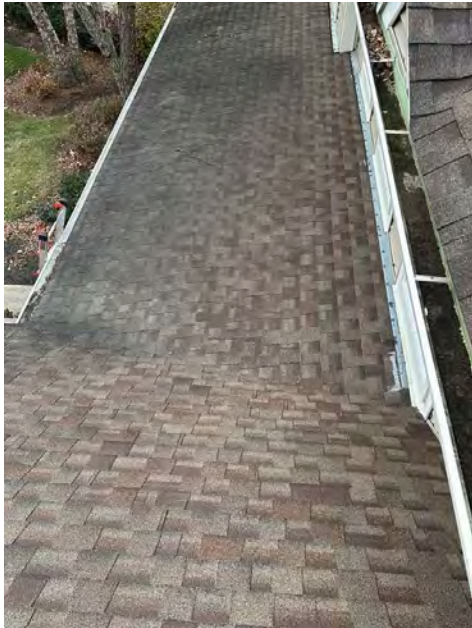
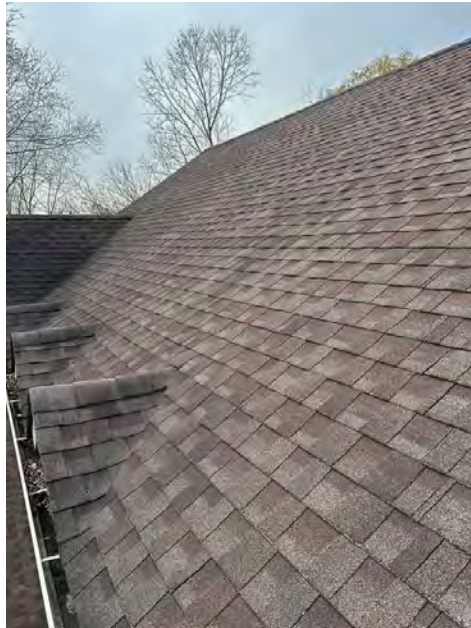
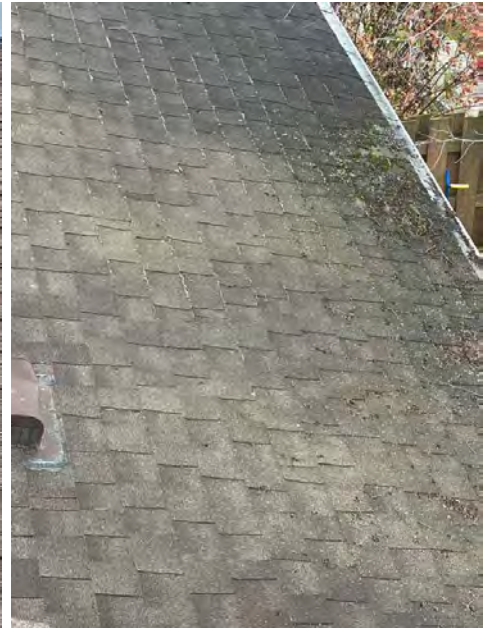
The soft section indicates a potential sub roofing framing failure due to a moisture condition or an inadequate framing installation.

Have further evaluated and repaired

[Consult a qualified roofing contractor for evaluation and repair.](#)

Contact a qualified roofing professional.

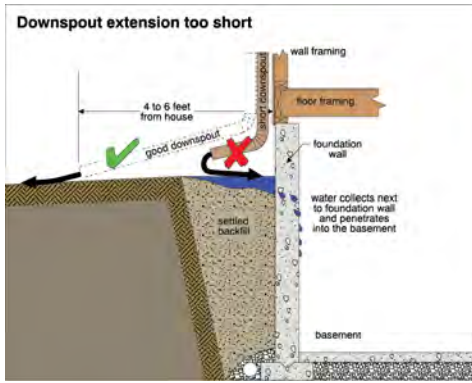
The downspout/s should discharge above the grade onto the ground at least six feet from the structure. There is a potential for water to collect next to the foundation wall and enter into the interior.

Example

[Consult a qualified gutter contractor for repair.](#)

Contact a qualified gutter contractor

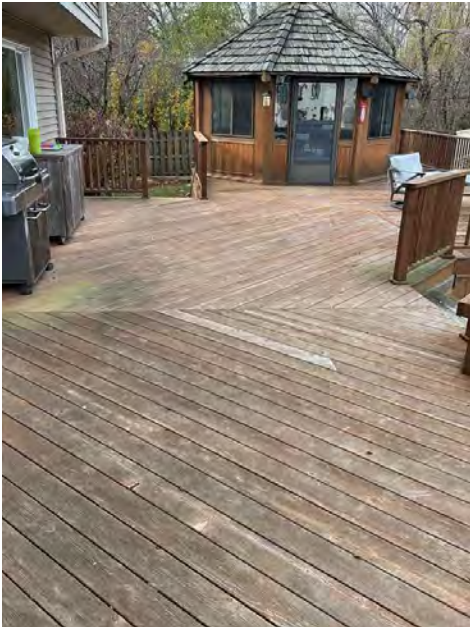
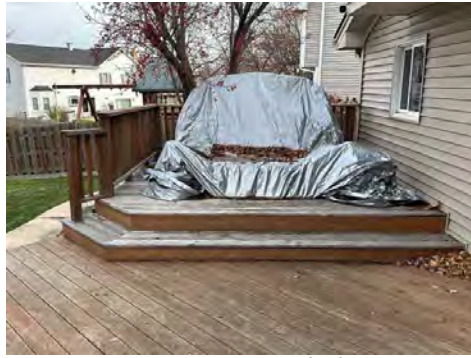
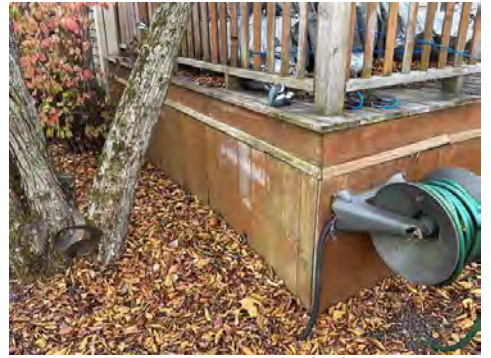
3.8.2 Porches, Decks, and Balconies

PAINT OR STAIN NEEDED

An unsealed deck may lead to material failure and promote rot. The lack of maintenance can potentially cause an unsafe condition.

Maintenance recommended

[Consult a qualified deck contractor for repair.](#)

Contact a qualified deck contractor.

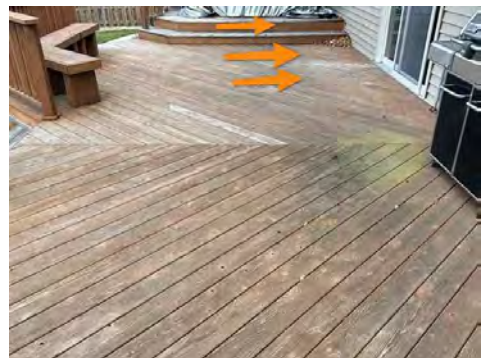
3.8.3 Porches, Decks, and Balconies

Slope of raised area of the deck was improperly sloping towards the structure. This could direct water into structure, cause water damage.

Have further evaluated and repaired if necessary

[Consult a decking contractor for further evaluation and repairs if needed.](#)

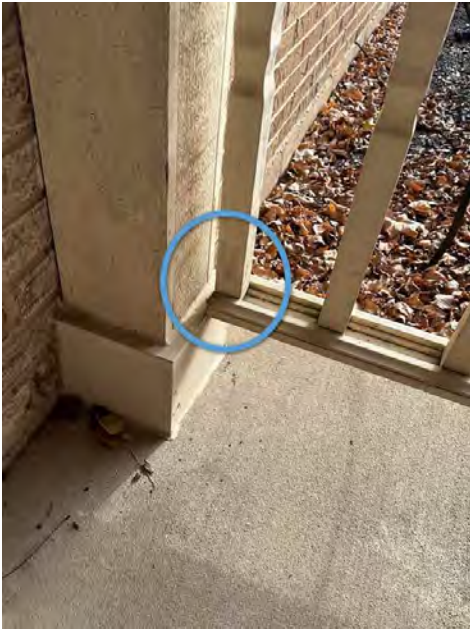
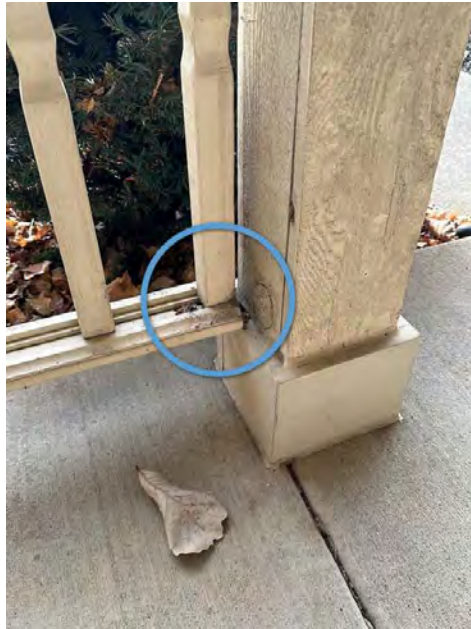
3.9.1 Railings, Guards and Handrails

The connection can potentially weaken and fail, causing an unsafe condition.

Repair

[Consult a qualified carpentry contractor for repair.](#)

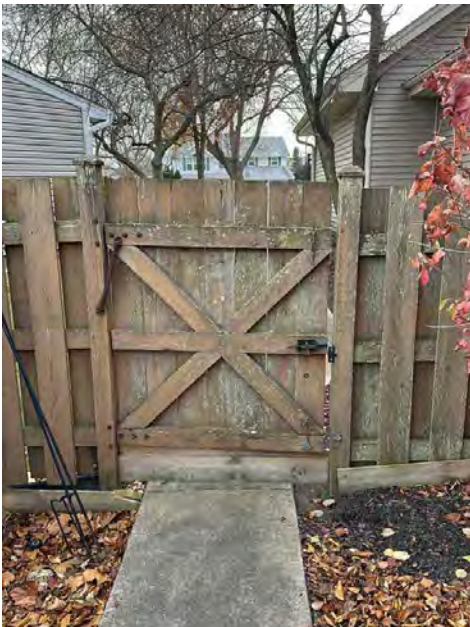
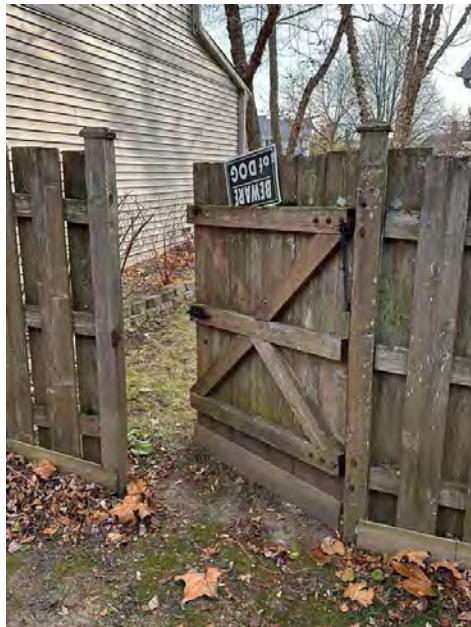
3.14.1 Fence

GATE DAMAGED

Chance for further material damage, weakened structure.
[Consult a qualified fence contractor for repair.](#)

East Exterior- Repair

West Exterior- Repair

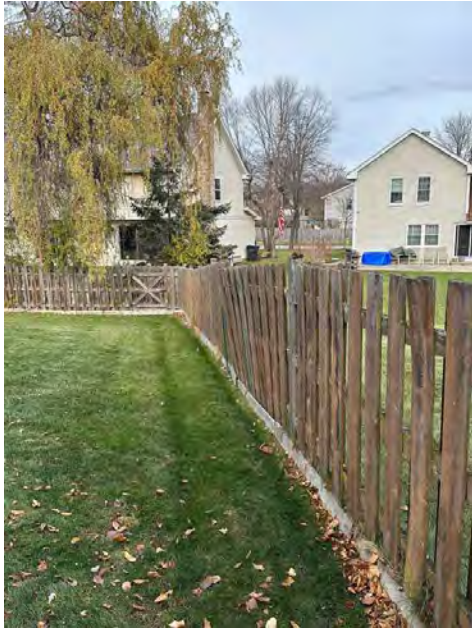
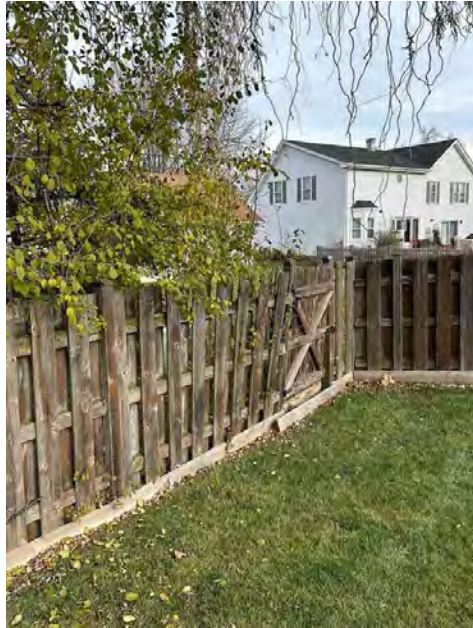
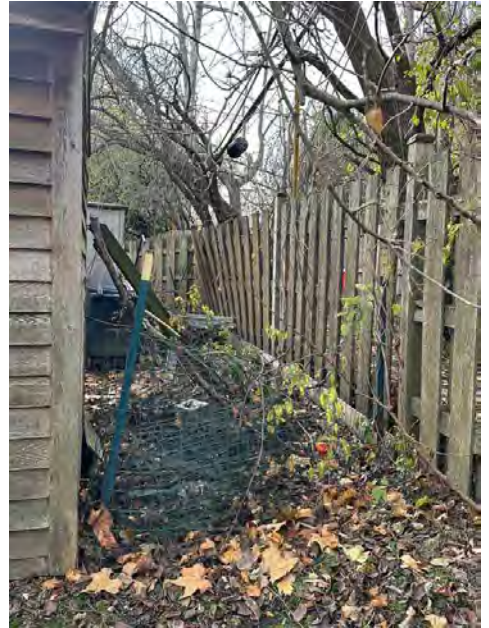
3.14.2 Fence

Physical injuries/material damage.

East Exterior- Repair

North Exterior- Repair

West Exterior- Repair

[Consult a qualified fence contractor for repair.](#)

Contact a qualified fencing contractor

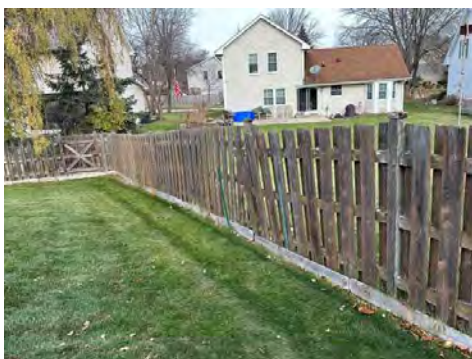
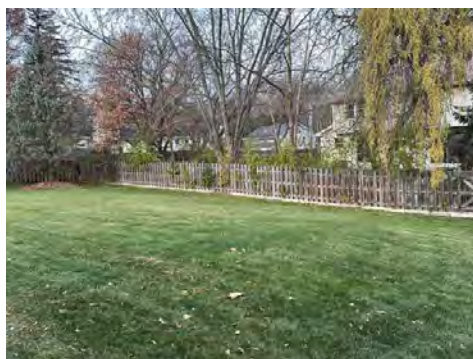
3.14.3 Fence

OLD/DETERIORATED

Wood fence was in poor condition, not properly maintained. Budget a cost to replace.

Budget to replace

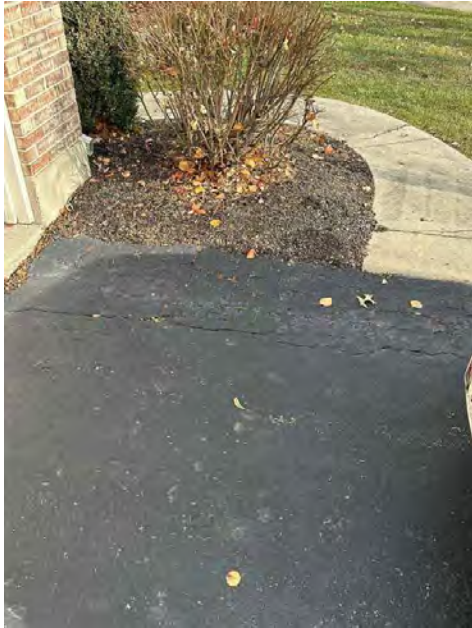
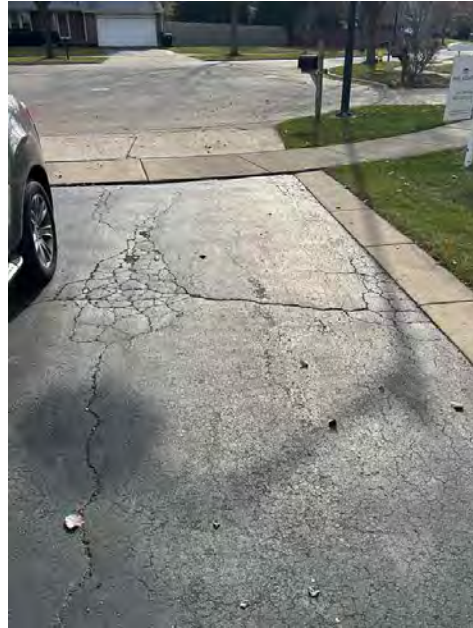
3.17.1 Walkways and Driveways

ASPHALT CRACKS

Chance for further material deterioration, drainage condition and a potential trip and fall hazard.

Repair

[Consult a qualified driveway contractor for repair as needed.](#)

Contact a qualified driveway contractor.

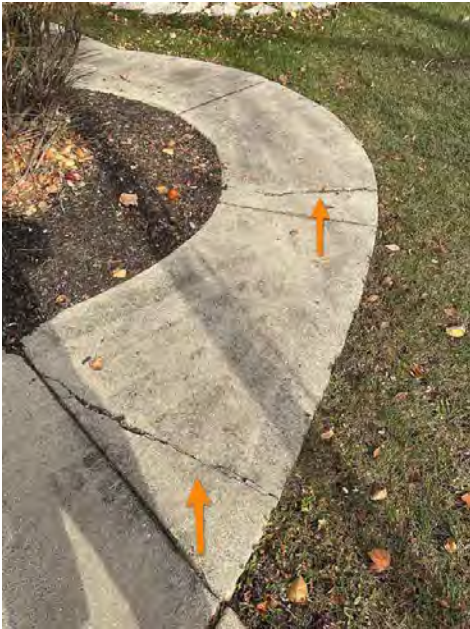
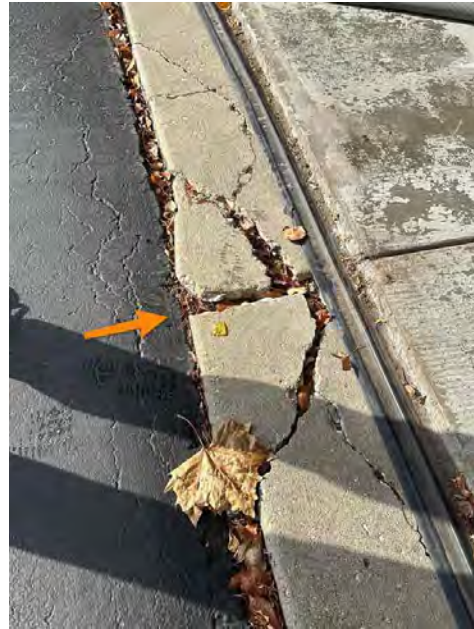
3.17.2 Walkways and Driveways

CONCRETE CRACKING AND SETTLING

Concrete settlement and cracks occur due to a poor base underneath and water. Chance for further material deterioration, settlement. Potential trip hazard.

East Exterior- Repair

Driveway- Repair

[Consult a qualified concrete contractor for repair.](#)

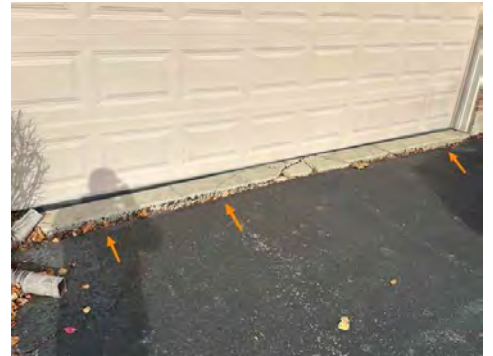
3.17.3 Walkways and Driveways

Chance for further material settlement. The uneven surface is a potential trip fall hazard.

Repair

[Consult a qualified asphalt contractor for repair.](#)

Contact a qualified driveway contractor.

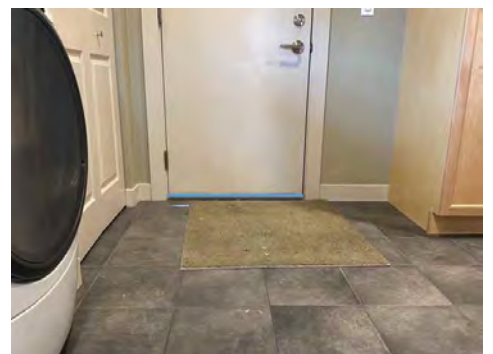
AIR LEAKS/WEATHER-STRIPPING MISSING

This can reduce comfort, cause air leaks and moisture conditions.

Repair

[Consult a qualified door contractor for evaluation and repair.](#)

Contact a qualified door repair/installation contractor.

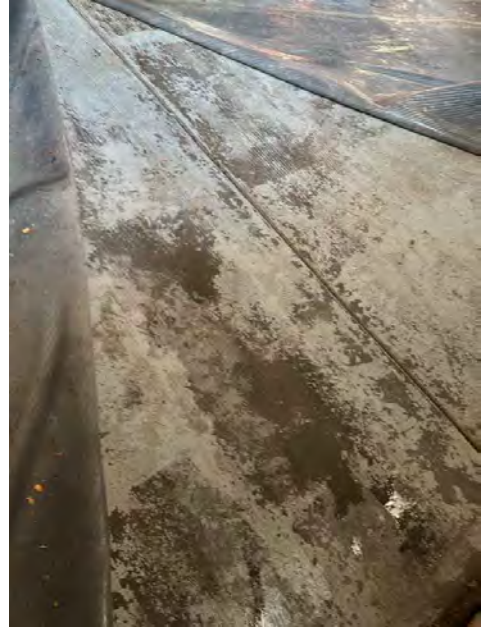
4.6.1 Garage Floor

MAINTENANCE RECOMMENDED

Garage floor surface finish has deteriorated over time. Maintenance to surface a finish will help prolong the material life span.

Maintenance recommended

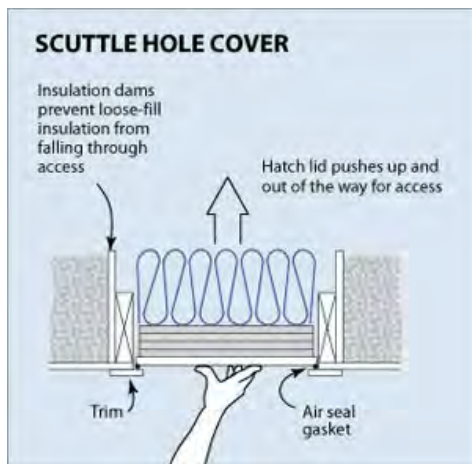
Attic hatch should be insulated and weather-stripped. This will increase comfort and reduce moisture conditions.

Access Cover Insulation Illustration

Contact a qualified insulation contractor.

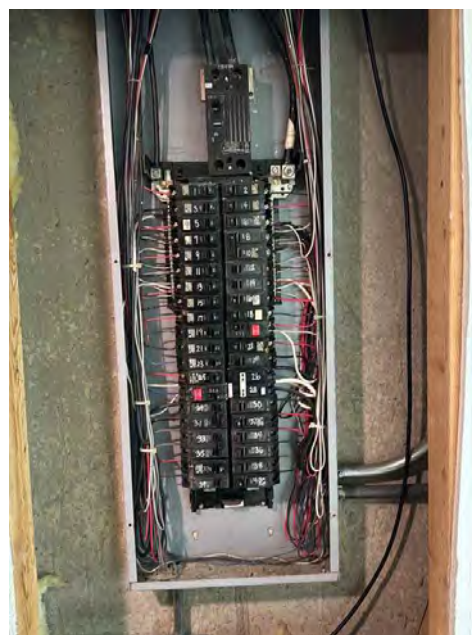
4 remaining slots

[Consult a qualified electrical contractor for replacement.](#)

Contact a qualified electrical contractor.

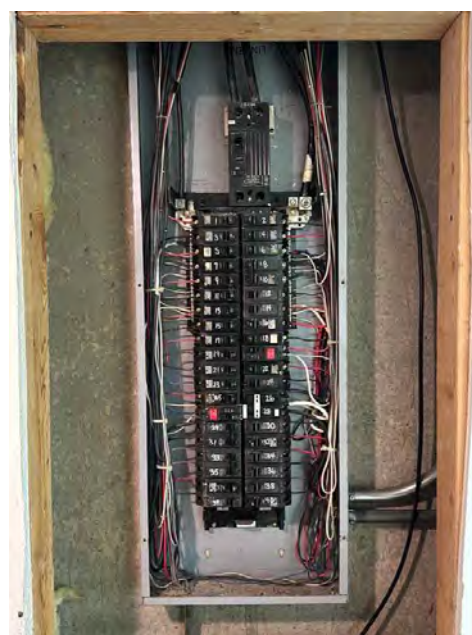
7.6.2 Electrical Panel & Breakers

Suggest installing barrier

Contact a qualified electrical contractor.

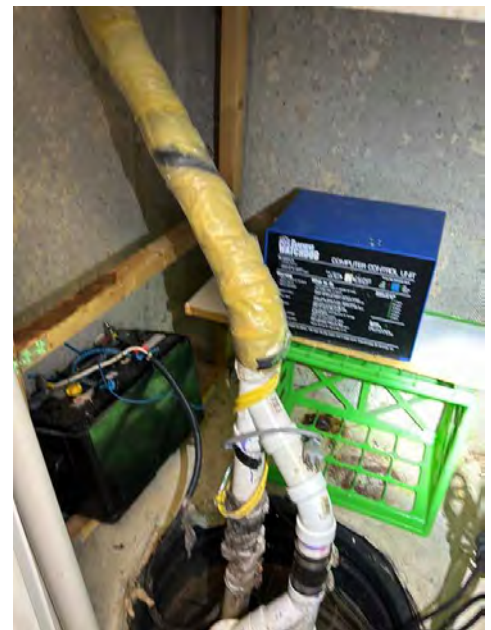
Battery not functioning, replacement needed

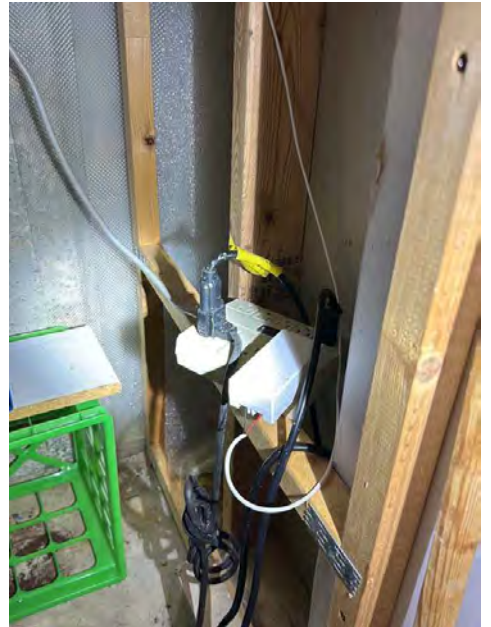
8.6.3 Sump Pump

Surge protector not proper, suggest designated outlet

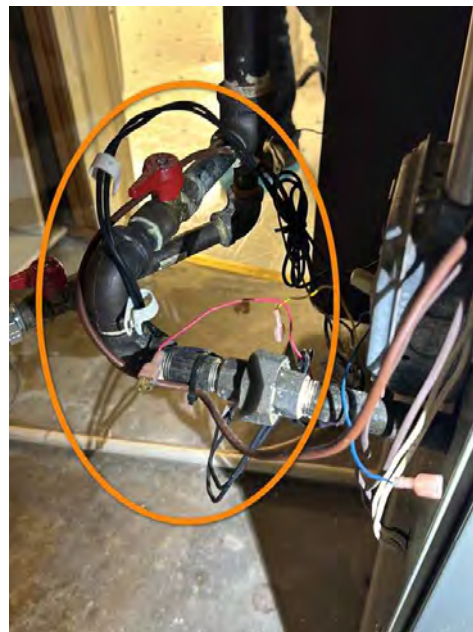
9.3.4 Furnace/Space Heater /Humidifier

Suggest installing

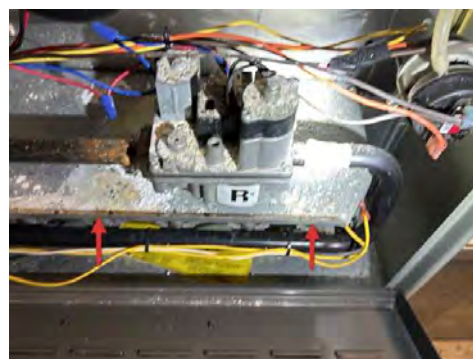
9.3.5 Furnace/Space Heater /Humidifier

Have further evaluated and repaired/replaced

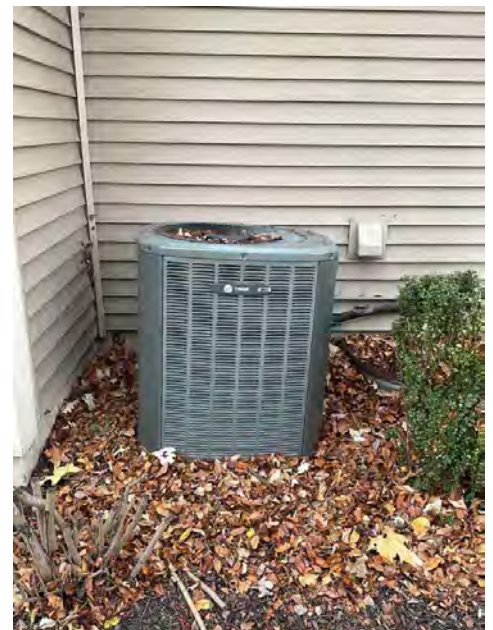
21 years- Budget to replace

Contact a qualified HVAC professional.

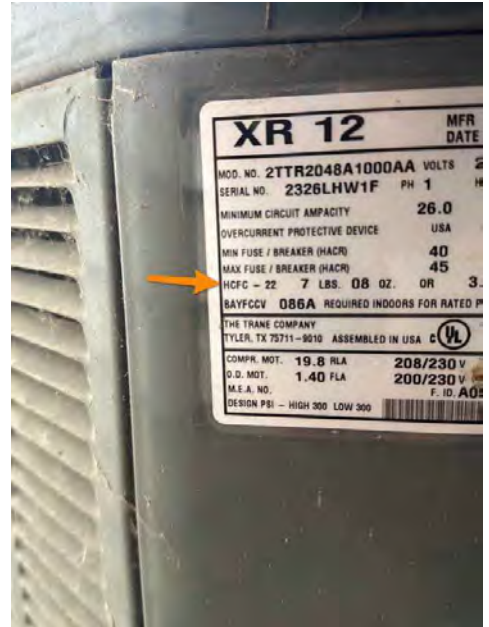
9.5.3 Cooling System

Expensive to charge

Contact a qualified HVAC professional.

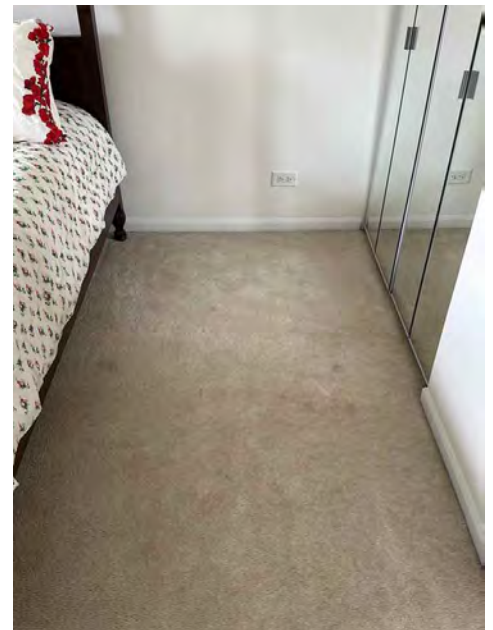
10.7.1 Flooring

North Bedroom- Suggest cleaning

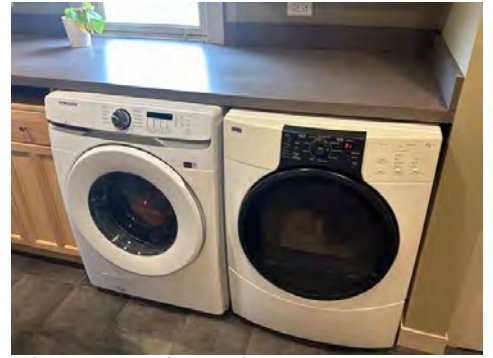
Hidden conditions may exist that are not documented in this report.

Observation limited

[Suggest pulling out the units to check for any irregularities.](#)
